INDOOR AIR QUALITY ASSESSMENT

**Pakachoag Elementary School
110 Pakachoag Street
Auburn, Massachusetts**

Prepared by:
Massachusetts Department of Public Health
Bureau of Environmental Health Assessment
June, 2001

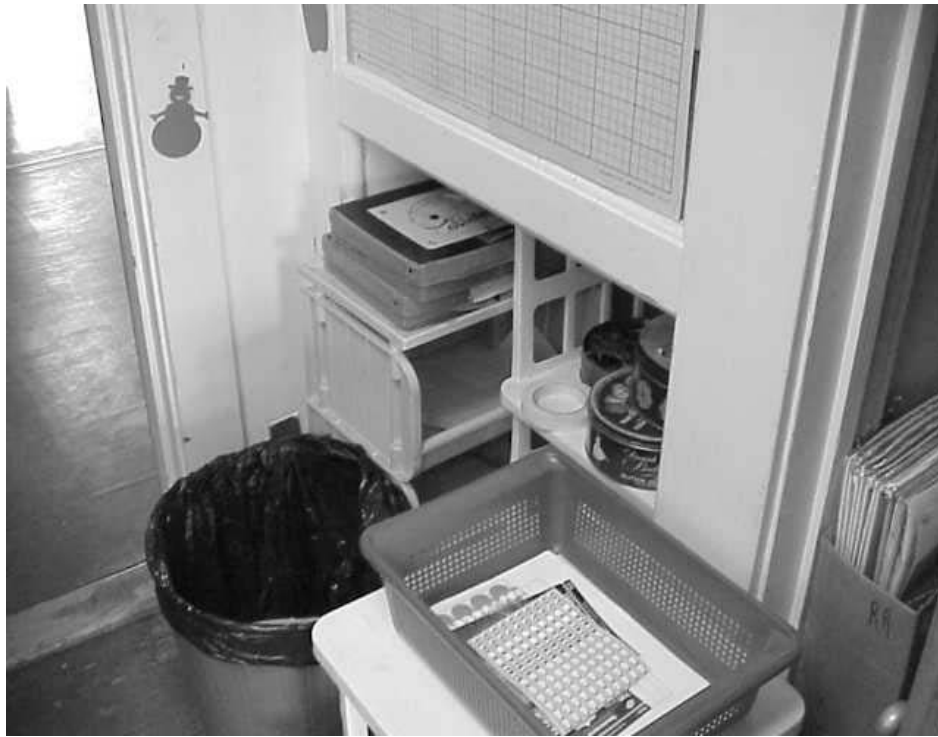
Picture 1

The building appears to have two different types of exhaust ventilation systems. The 1928 wing appears to have a gravity exhaust system, which uses rising heated air and a vent/chimney to remove air from classrooms (see Picture 1). Airflow into these vents is controlled by a louver system within the duct. Minimal airflow was detected in these vents and many were obstructed with a variety of materials (see Pictures 2 and 2A). The exhaust vents are located in the lower wall of coat closets in classrooms. Classroom air is drawn through a space beneath the closet door. This design allows for these vents to be easily blocked by stored materials. In a number of classrooms vents were blocked with books, book bags, boxes and other obstructions.

Gravity Exhaust Vent Used for Storage

1. Remove all blockages from univents and exhaust vents.
2. Repair inoperable univents where feasible.
3. Repair inoperable exhaust vents.
4. For buildings in New England, periods of low relative humidity during the winter are often unavoidable. Therefore, scrupulous cleaning practices should be adopted to minimize common indoor air contaminants whose irritant effects can be enhanced when the relative humidity is low. To control for dusts, a high efficiency particulate arrestance (HEPA) filter equipped vacuum cleaner in conjunction with wet wiping of all surfaces is recommended. Avoid the use of feather dusters. Drinking water during the day can help ease some symptoms associated with a dry environment (throat and sinus irritations).

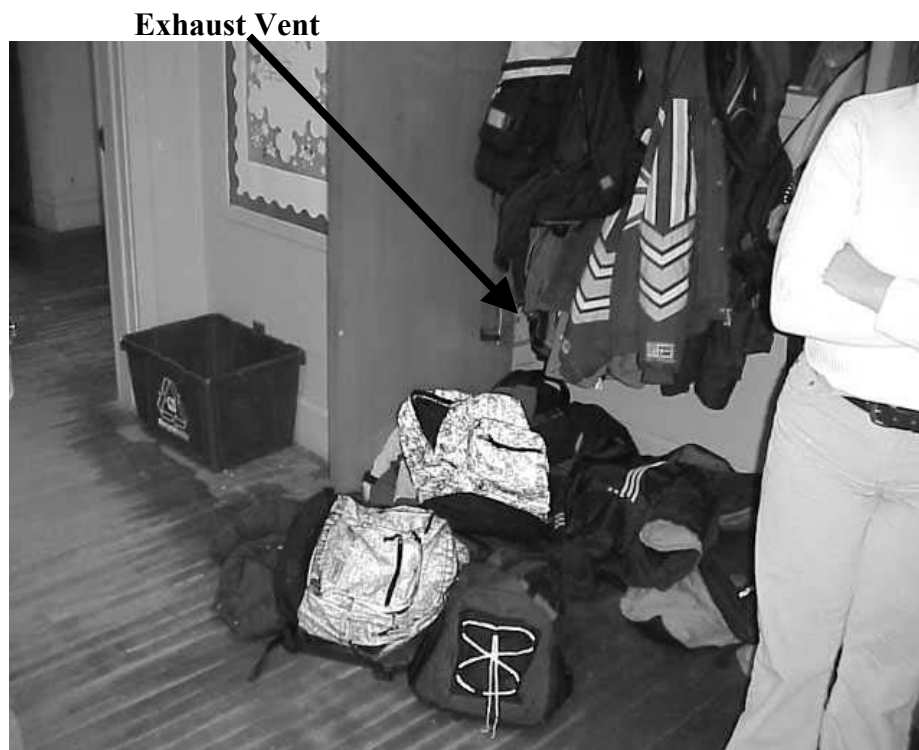
Picture 2

Closet Exhaust Vent Blocked in Closet

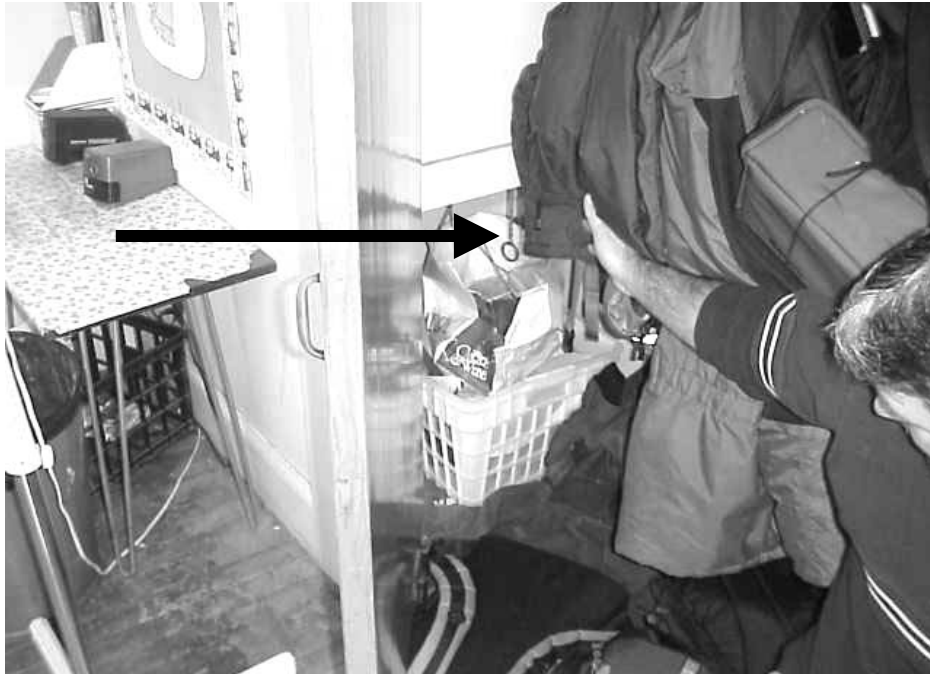
Picture 2A

Blocked Exhaust Vent, Note Pull Chain That Controls the Vent Louver System

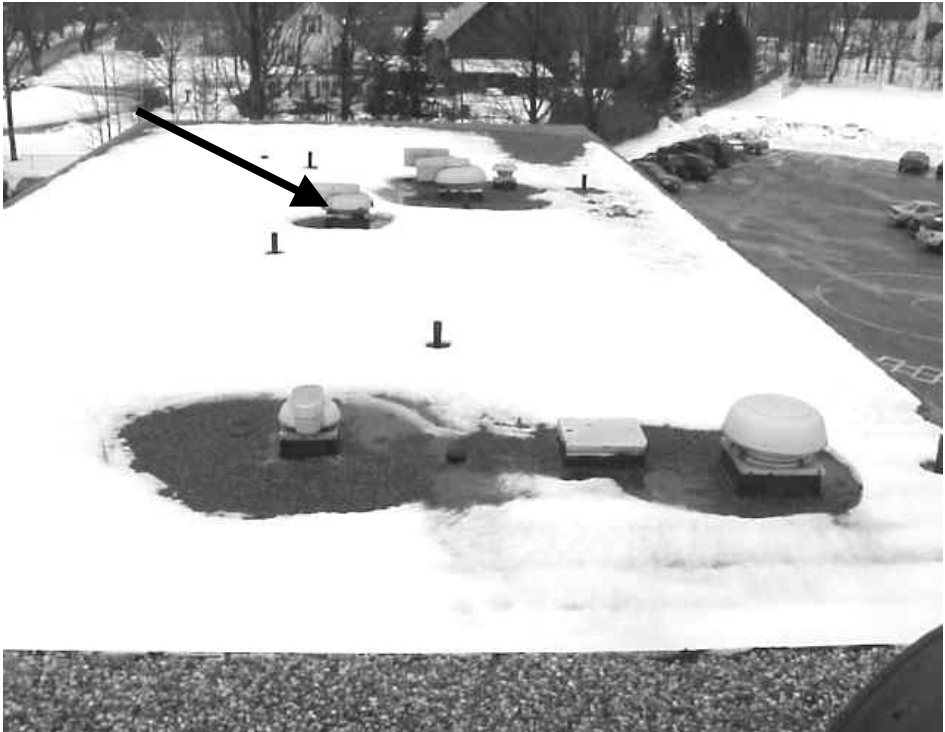
Picture 3

The 1961 wing uses motorized exhaust vents to eject air drawn from classrooms through wall-mounted air ducts. Exhaust vents in several classrooms did not appear to be drawing air indicating that several exhaust vent motors were likely inoperable and/or in need of repair (see Picture 3).

Rooftop Exhaust Vent Motors

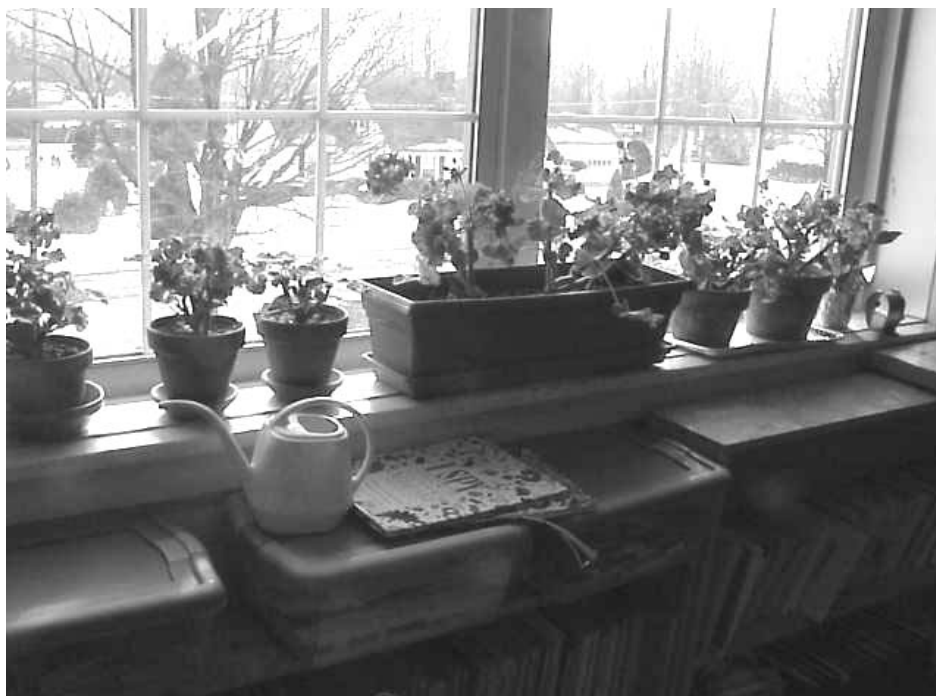
Picture 4

Several classrooms had a number of plants (see Picture 4). Plant soil and drip pans can serve as source of mold growth. A number of these plants did not have drip pans or were in outdoor type planters with no drainage. The lack of drip pans and drainage can lead to water pooling and mold growth on windowsills when used indoors. Wooden sills can be potentially colonized by mold growth and serve as a source of mold odor. Plants should also be located away from univents to prevent the aerosolization of dirt, pollen or mold.

Flowering Plants In Classroom

5. Move plants away from univents in classrooms. Ensure plants have drip pans. Examine drip pans periodically for mold growth and disinfect with an appropriate antimicrobial where necessary.

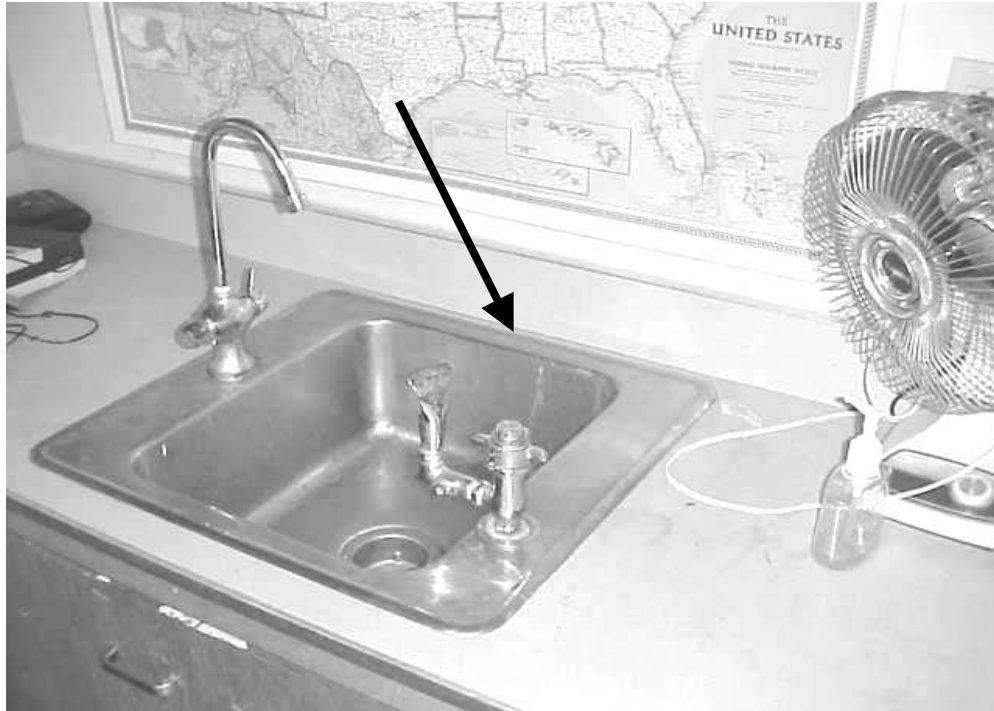
Picture 5

Several classrooms have sinks that have a seam between the countertop and wall (see Picture 5). Water penetration through this seam can result if not watertight. Water penetration and chronic exposure to wood and plywood can cause these materials to swell and serve as a growth medium for mold.

Sink/Backsplash Seam That Can Be Subject to Water Damage

8. Render holes in walls around utility pipes with an appropriate sealant compound.
9. Consider increasing the dust spot efficiency of univent filters.
10. Repair water damage to sink counter tops. Seal the counter/backsplash seam with a waterproof sealing compound.

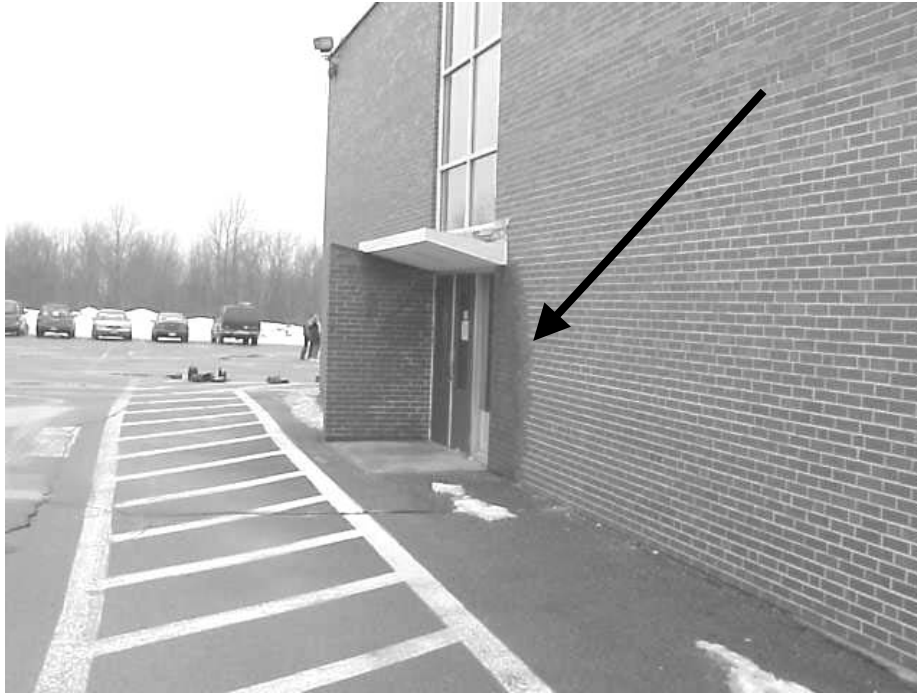
Picture 6

Excessive water damage to brickwork was noted on the south exterior wall of the building. Over time, rainwater can work its way into mortar and brickwork causing cracks and fissures, which can lead to water penetration. Pooling water was noted on the cantilever roof over the exterior door (see Picture 6). Note that this roof is pitched *towards* the exterior wall, and has no support beneath it. The added weight of the water can increase tension, pulling the structure away from the building, and ultimately damaging the brickwork. Missing and/or damaged brickwork compromises the integrity of the building envelope and can provide a means of egress for moisture into the building.

Cantilever Roof on South Wall, Note Water Stain on Exterior Wall

1. Examine the feasibility of providing better drainage for the roof shown in Picture 6.
2. Consideration should be given to replace univents if parts cannot be obtained.

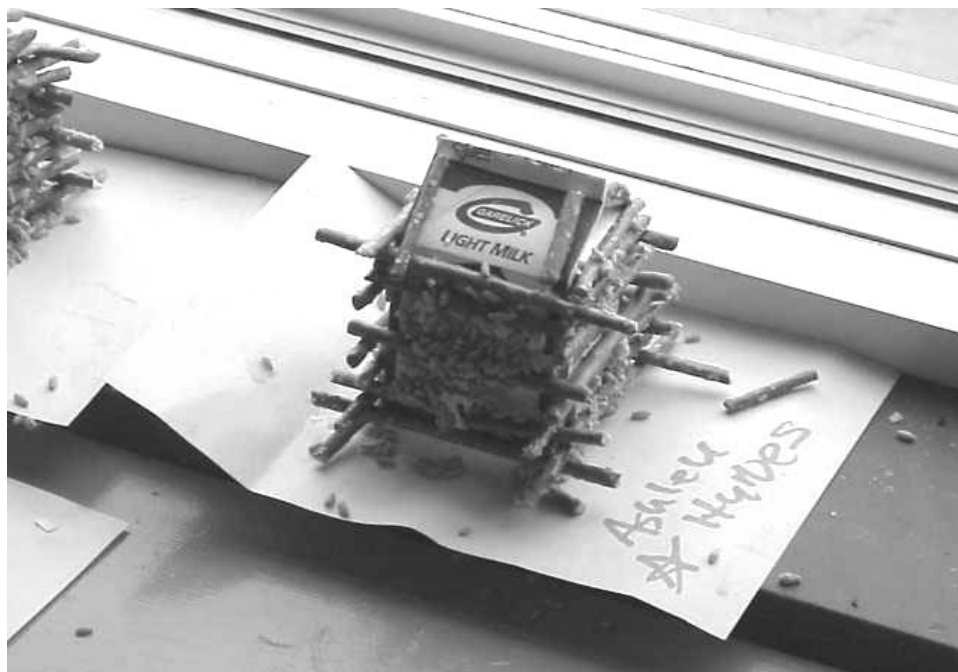
Picture 7

Student art projects constructed of milk cartons and pretzels were stored in classrooms and hallways (see Picture 7). A significant accumulation of stored soft drink

Pretzel/Milk Carton Art Project In Classroom

6. Consider installing local exhaust ventilation in teacher's room to operate during photocopying activities to remove excess heat and odors.
7. Remove food products and boxes to prevent the attraction of pests from classrooms.

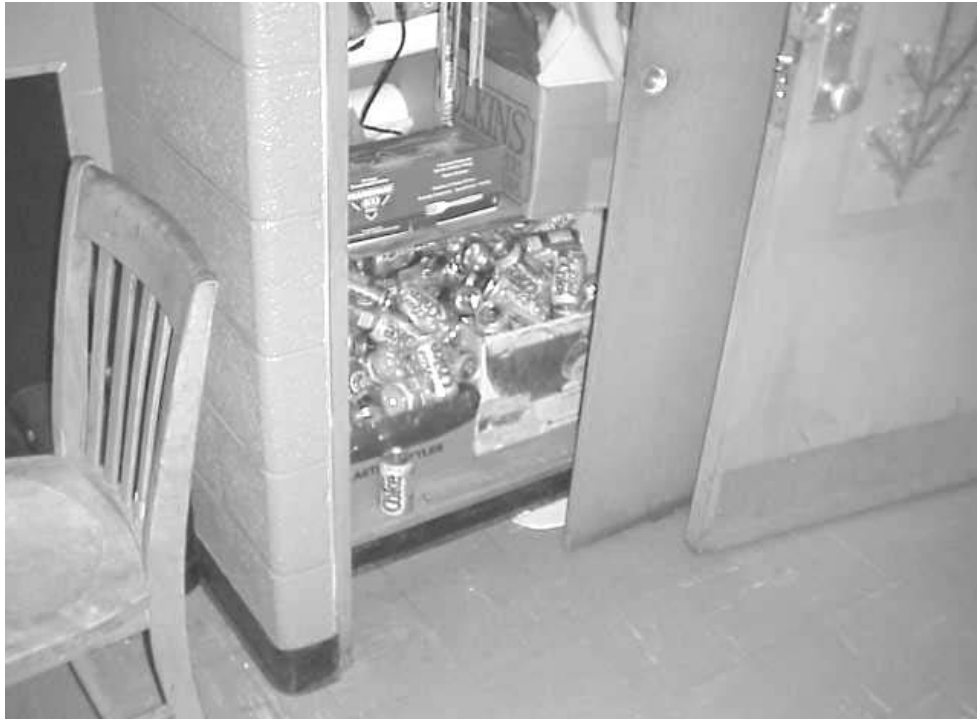
Picture 8

cans was noted in the teachers lounge (see Picture 8). Food and their containers may have residue that can serve to attract pests (e.g., mice and cockroaches). The use of these materials in art projects should be avoided to prevent the necessity for use of pesticides to rid the building of infestations.

Accumulated Soft Drink Containers in Closet

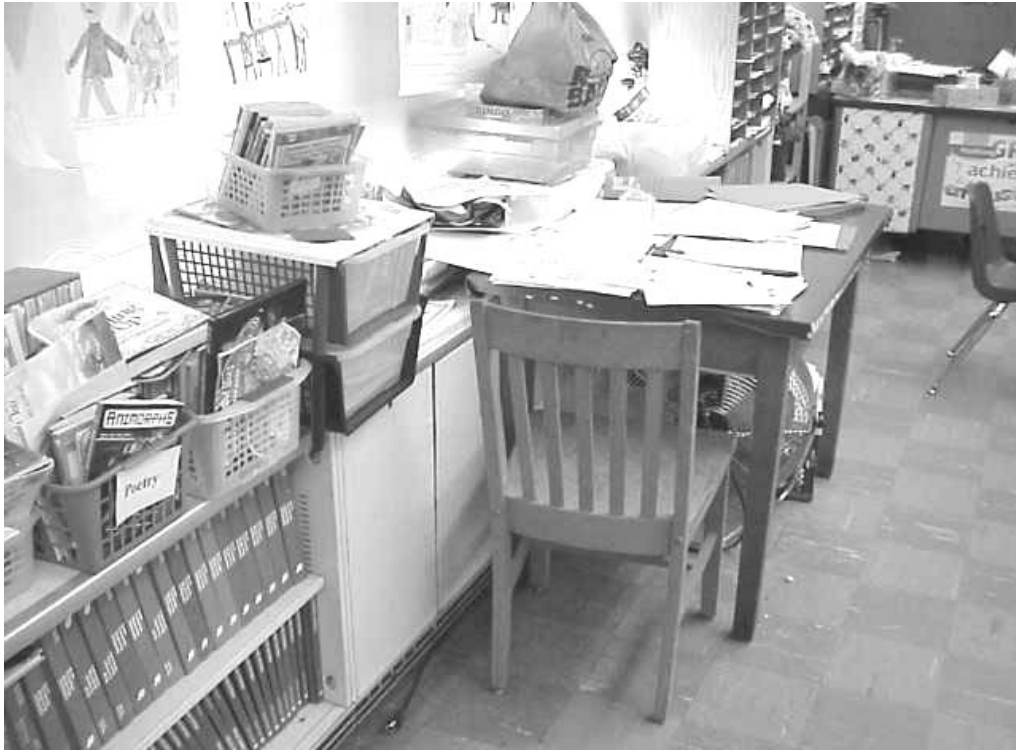
Picture 9

Also of note was the amount of materials stored inside classrooms (see Picture 9). In classrooms throughout the school, items were seen piled on windowsills, tabletops, counters, bookcases and desks. The large amount of items stored in classrooms provides a means for dusts, dirt and other potential respiratory irritants to accumulate. These items, (e.g., papers, folders, boxes, etc.) make it difficult for custodial staff to clean around these areas. Dust can be irritating to the eyes, nose and respiratory tract. Materials should be relocated and/or cleaned periodically to avoid excessive dust build up.

Accumulated Materials Stored in Classroom Blocking Univent

11. Relocate or consider reducing the amount of materials stored in classrooms to allow for more thorough cleaning. Clean items regularly with a wet cloth or sponge to prevent excessive dust build-up.

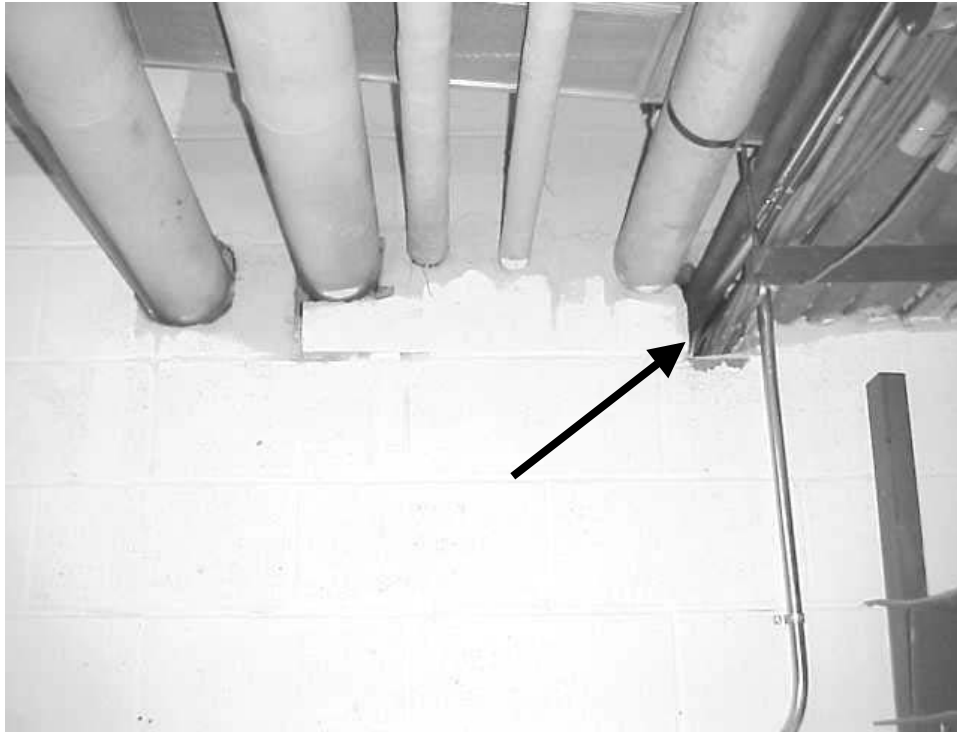
Picture 10

Open holes around utility pipes (see Picture 10) and doors that open into the wall cavities (see Picture 11 and 11A) were noted in walls in the basement. Open pipes and utility holes as well as into wall cavities can provide a means of egress for odors, fumes, dusts and vapors from the storage space into classrooms.

Utility Conduits/Pipes Penetrating Wall, Note Unsealed Hole

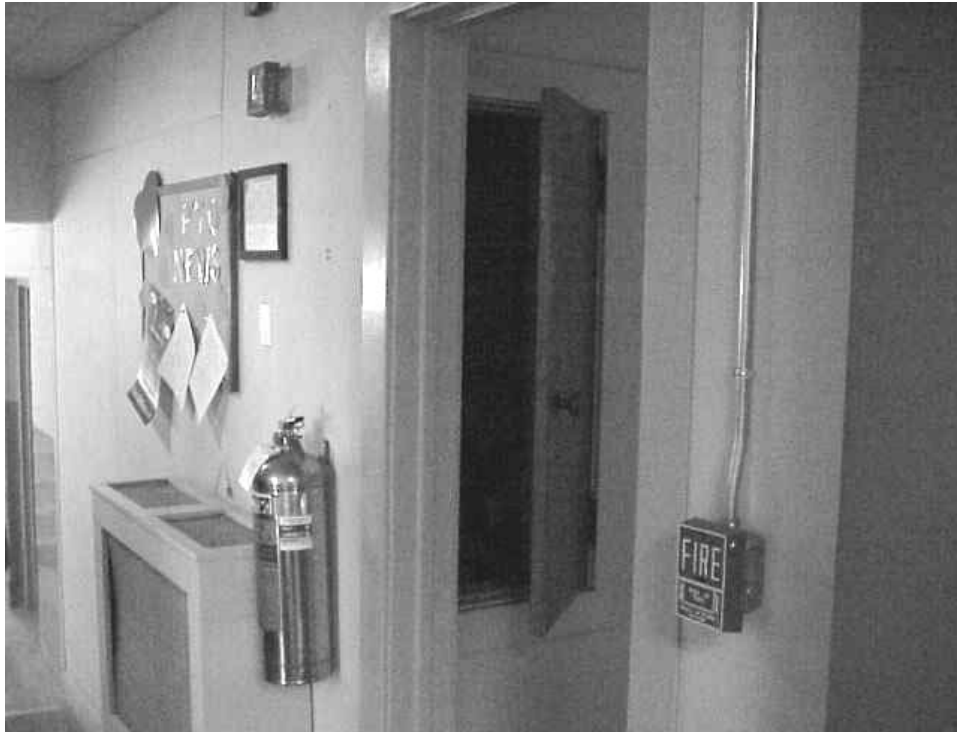
Picture 11

Door Into Wall Cavity

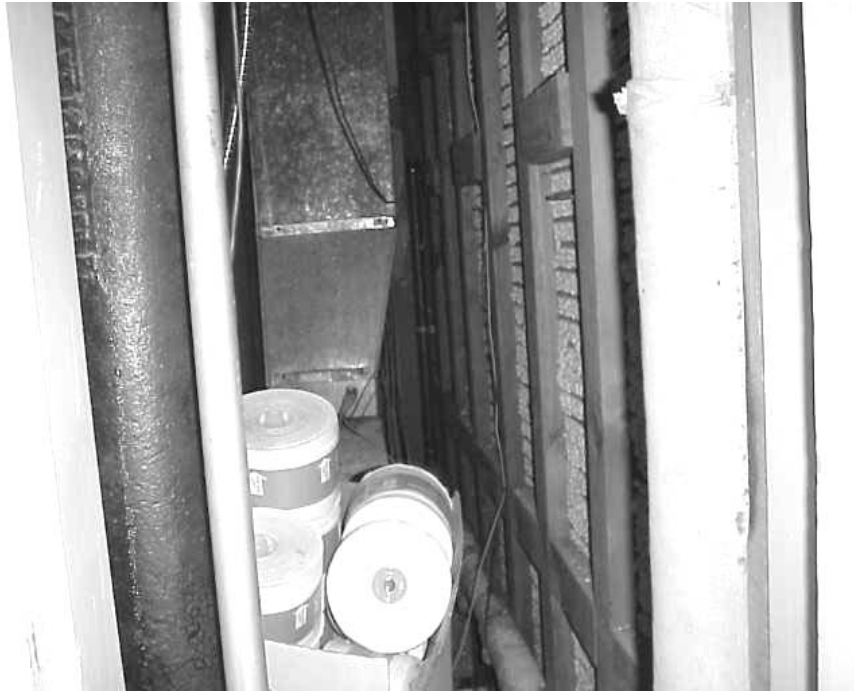
Picture 11A

Inside Of Wall Cavity Behind Door in Picture 11
